AERO - CONTACT News Letter III September, 2003

Advices for engine compressor IDB Check!

As a result of the crash investigation in Duxford/UK, on Friday Sept. 5th 2003 *aero-contact* was asked by the British AAIB to provide instructions for the L-39 operators on how to check the torque on the compressor IDB.

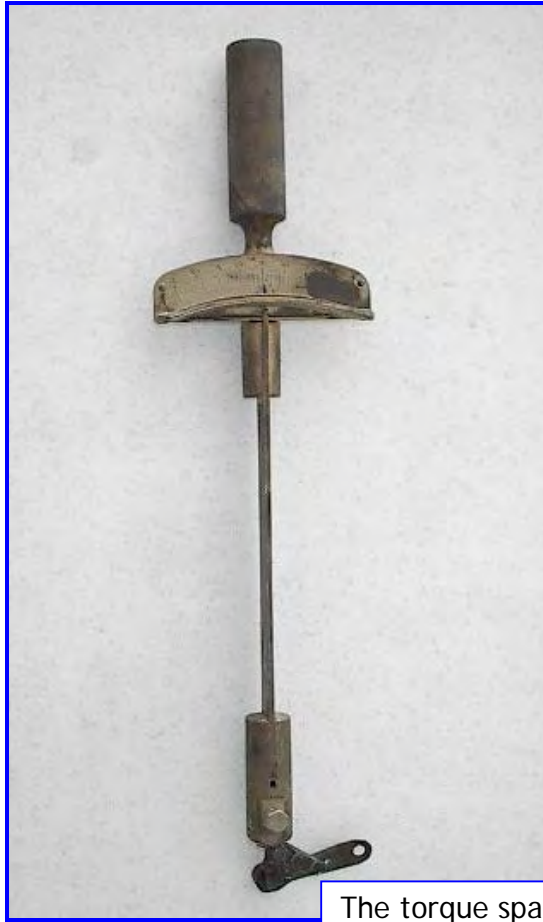
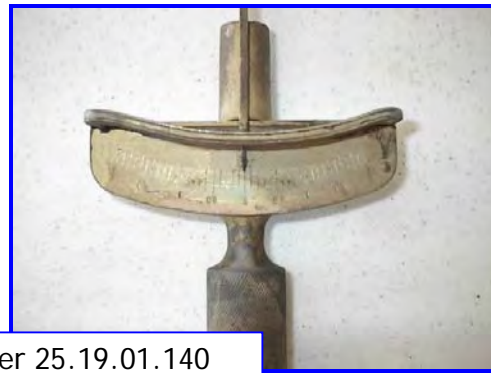
The torque spanner 25.19.01.140

Since 1983, the torque check is part of the work during the installation of **new or overhauled** engines and during the **100 and 200 hrs inspection**. In order to perform the torque check, the torque limiting spanner 25.19.01.140 out of the engine tool kit 25TL.19.00.030 must be used.

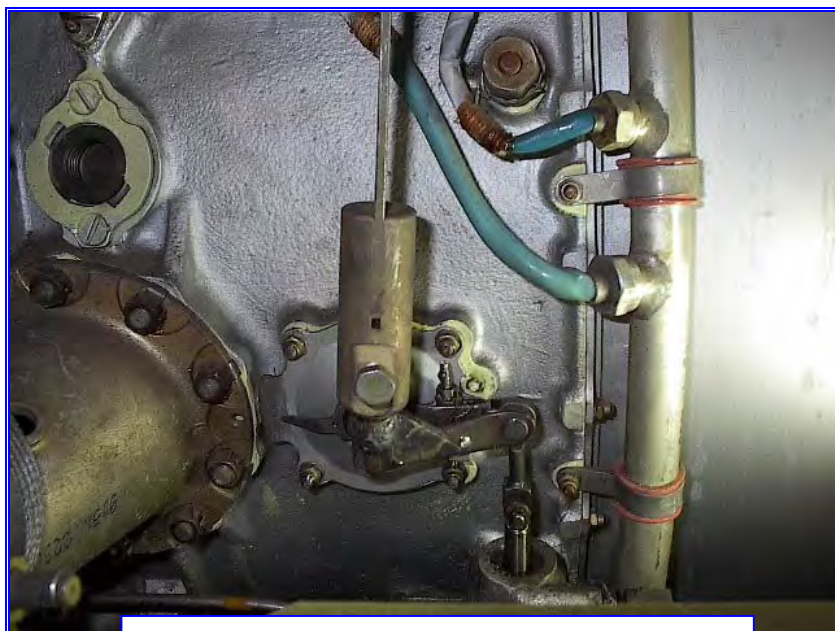
The torque spanner 25.19.01.140 mounted

The torque at engines in operation is normally between 0,3 and 0,8 kpm.
The torque check is only correct with the original torque wrench and its adapter for the IDB check and with disconnected actuator.
If you can turn the level pointer with both hands from its horizontal (-15°) position down to +5°, the torque is below 1,1 kpm (guaranteed).
