Flight Safety Information!

Skyline Aviation in Holland is operating L-39's since 1996. Some month ago we had a narrow escape when at low altitude the bleed air pipe for the engine intake heating system exploded. The full blowing bleed air reduced power so such that the plane had almost no more climbing power. It happened at the end of a mission, so at low all up weight. At full fuel the plane probably would not have been able to stay up.

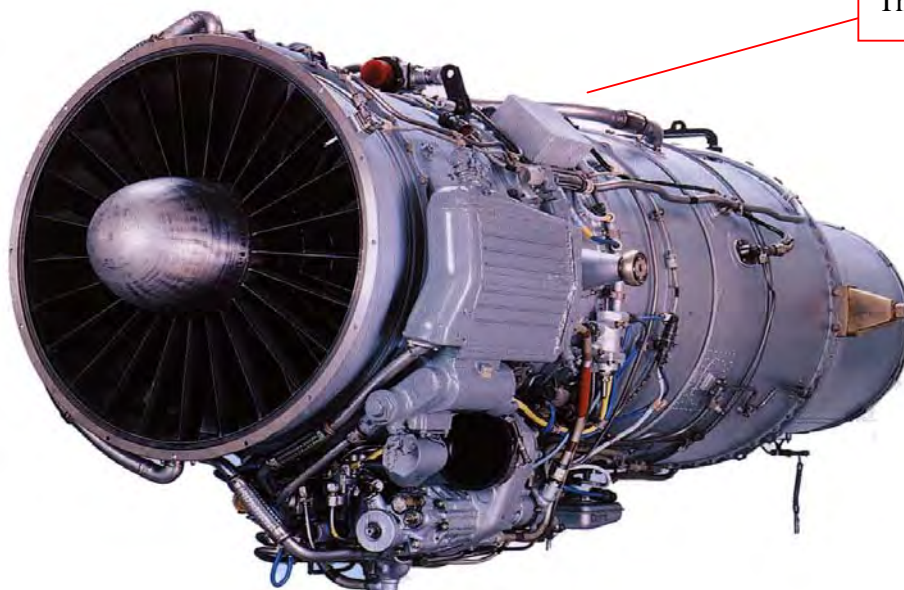
Where to look for it :

That's the pipe!

I was requested by Mr. Don Keating to make this information available to all L-39 Enthusiasts! The inspections above, as suggested by Alex should be carried out, prior to the next flight! The inspection should be completed with a strip of thin paper, which you or your mechanic should hold around the pipe at 1 inch distance during an engine run up. Just to discover any airflow caused by a crack or a hole in the welding / soldering area. Don't touch the line – This is very hot!!! (Please read my old News Letter August 2003 about melted engine cables – it's the same pipe!

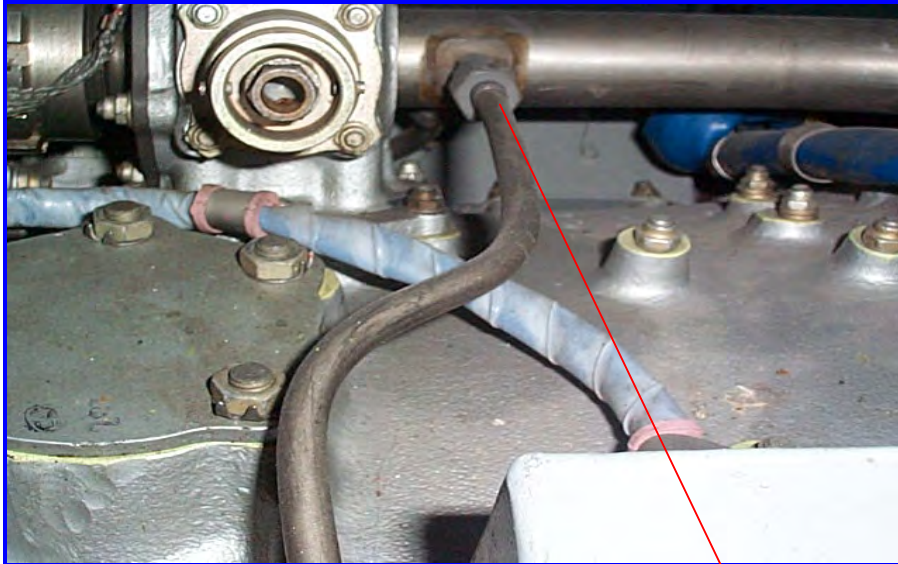
On top of the engine - left side!

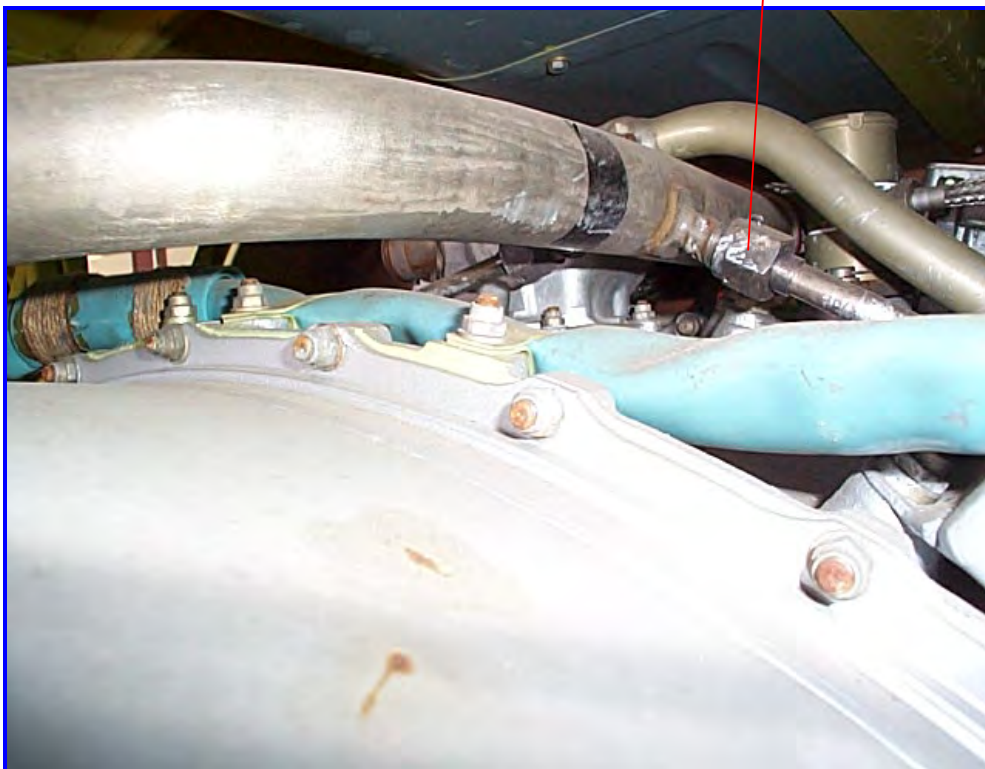
and from the rear - right side

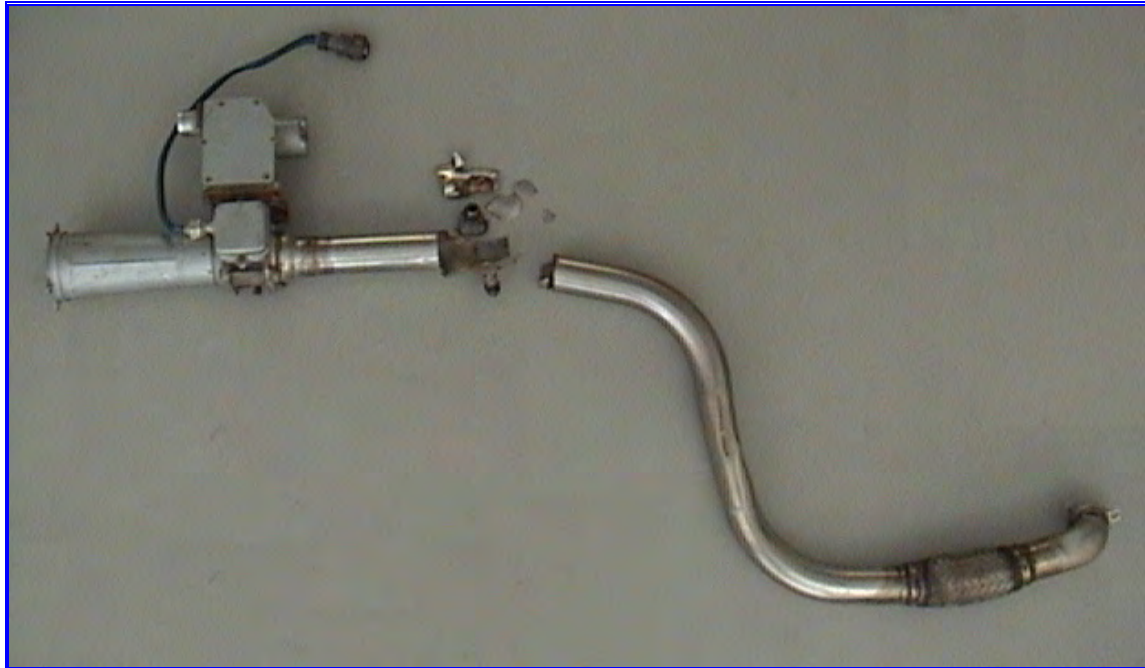
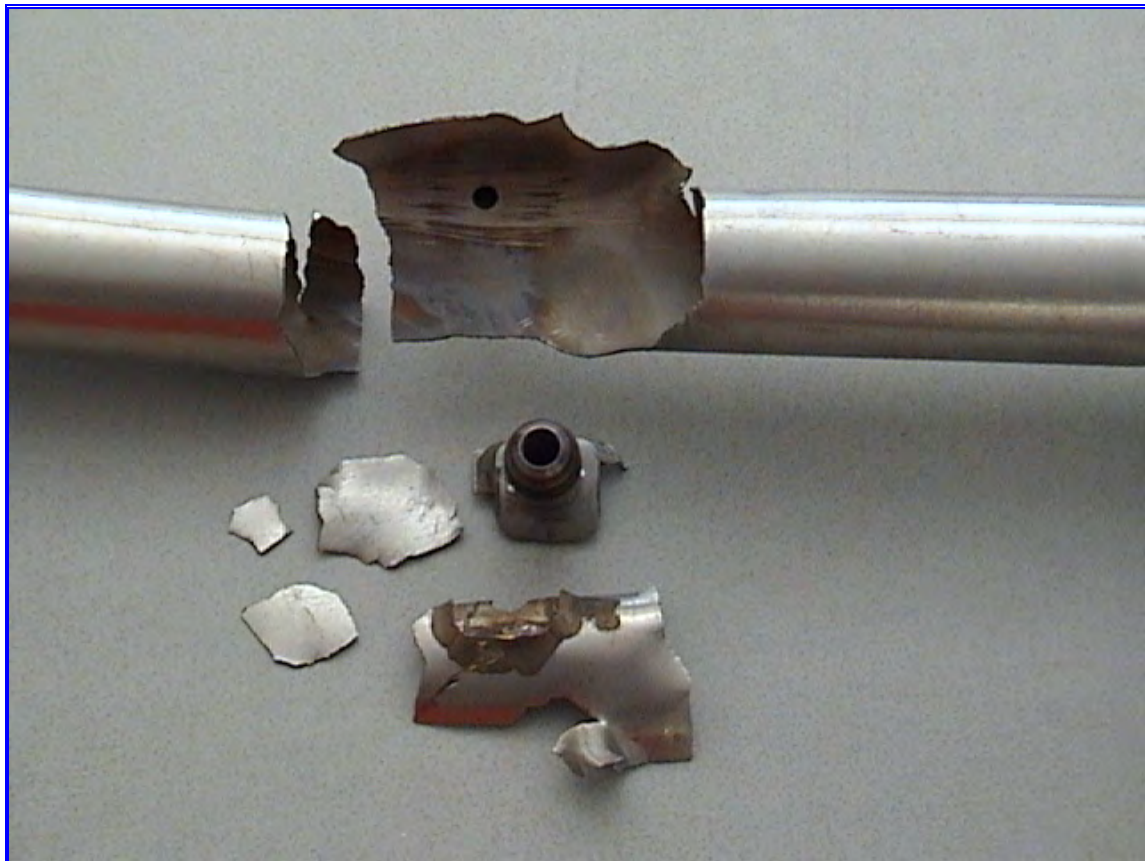
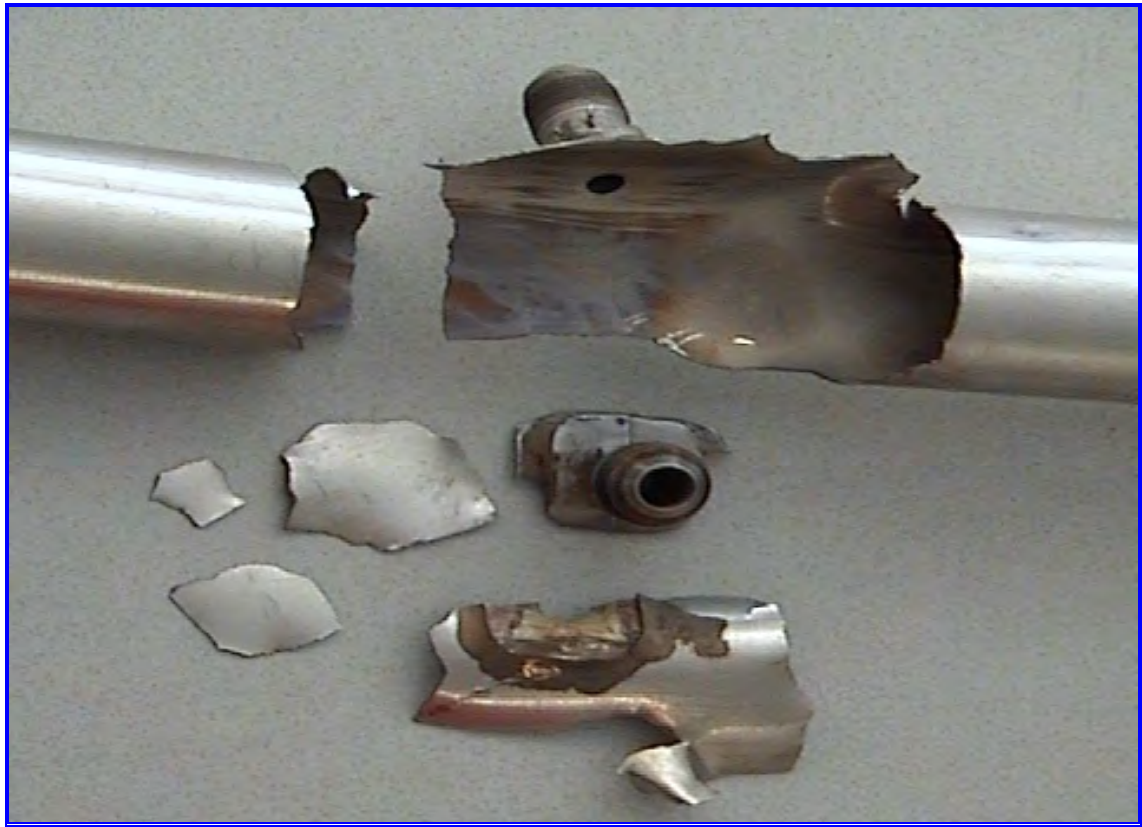
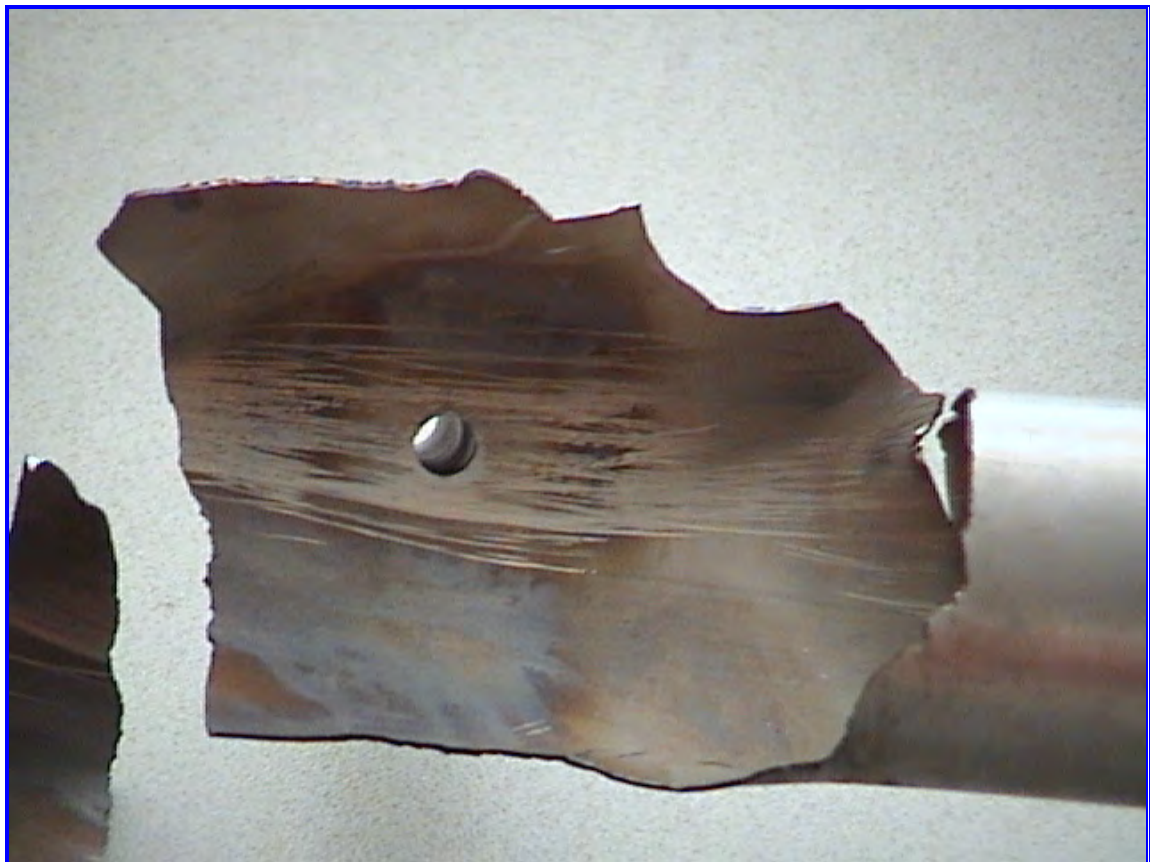
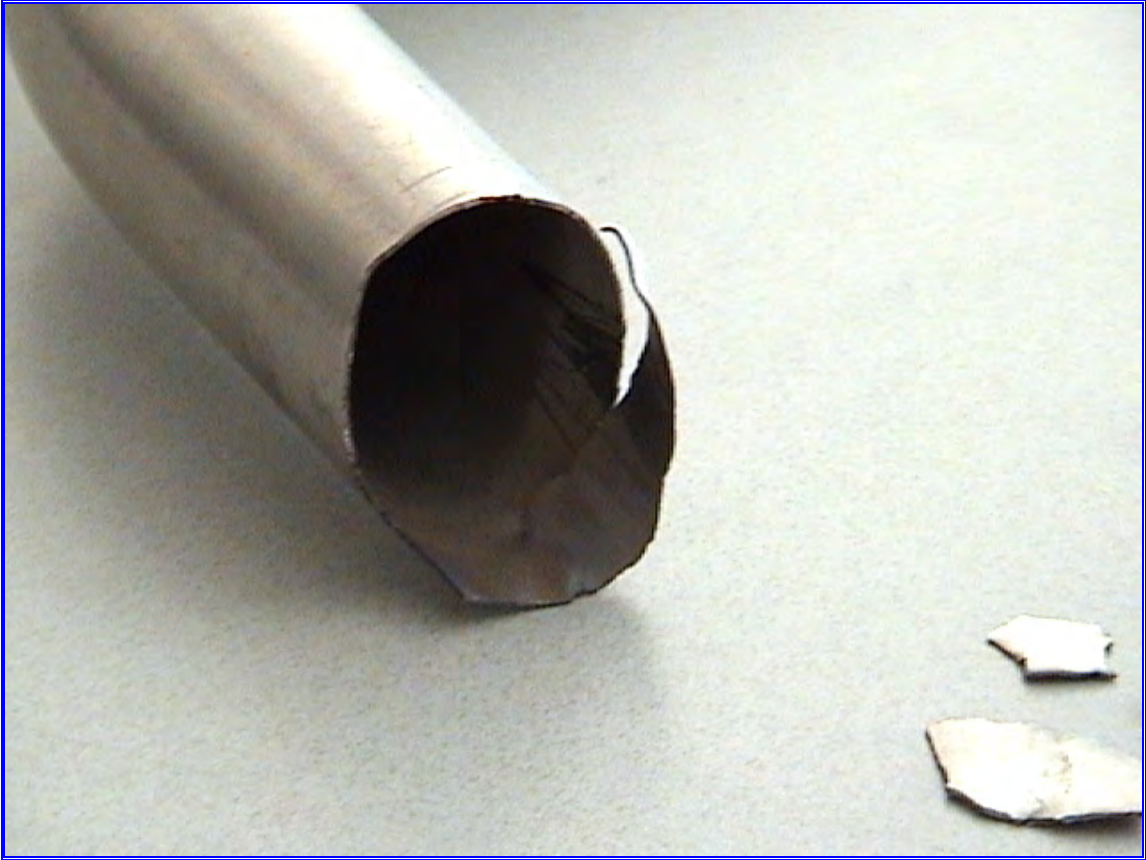
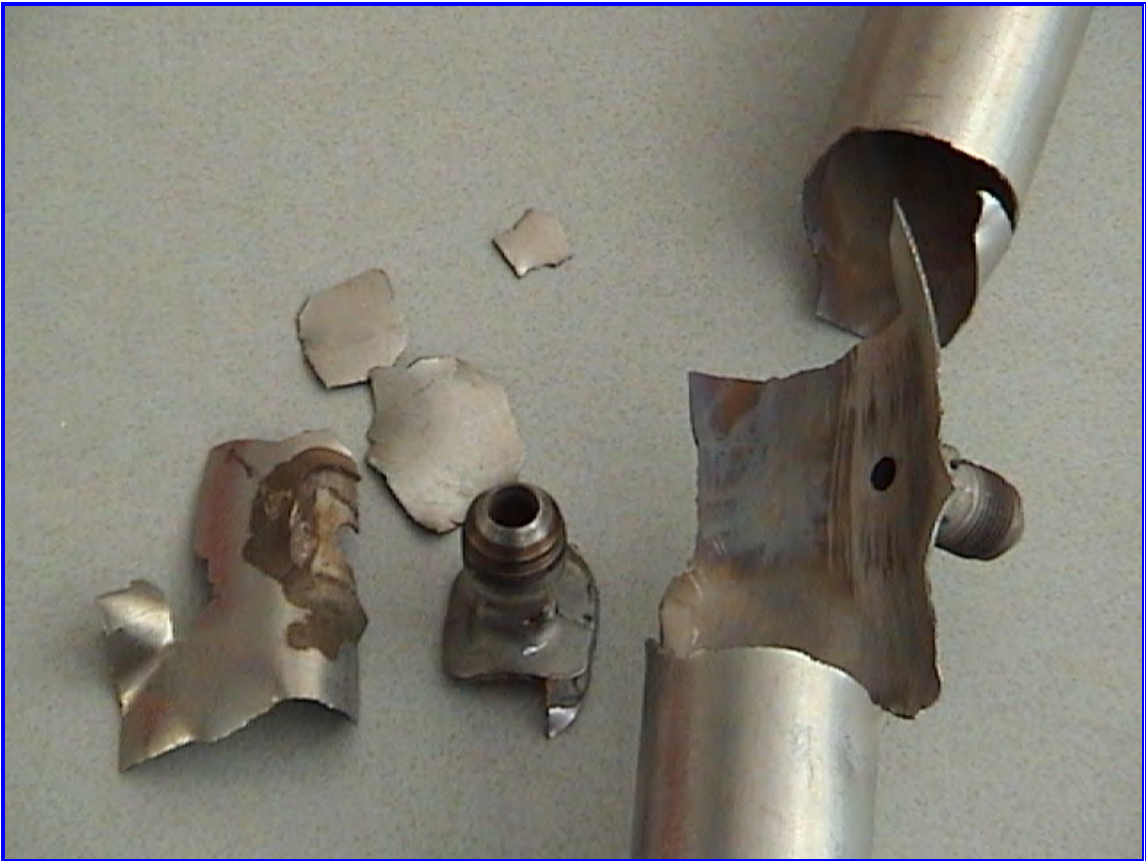
The pipe bust open at a position before the control valve at a welding point where the two small pressure / heating pipes to the Fuel Control Unit are connected each side. Probably a crack must have developed in the welding at the underside until it burst open, blowing a hole in the control rod fairing above it. I cannot upload pictures here but willing to mail those to anyone interested. I advise to check this area using mirror and light for cracks and let me know if anyone else has experienced the same so we should recommend to make it a mandatory inspection point.

Here it is as it was found after the flight :
