L-39 sabotaged !

During an L-39 inspection and repair in France last week we run into the following problem:

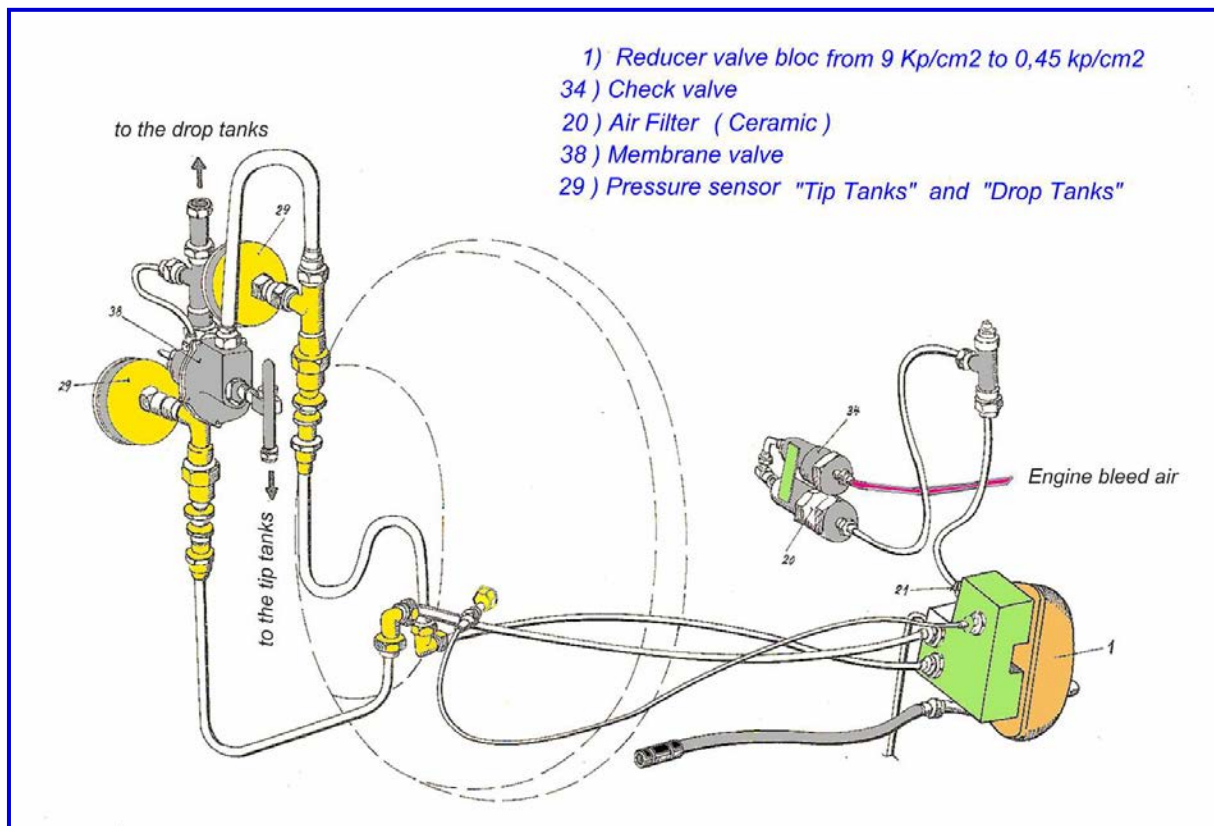
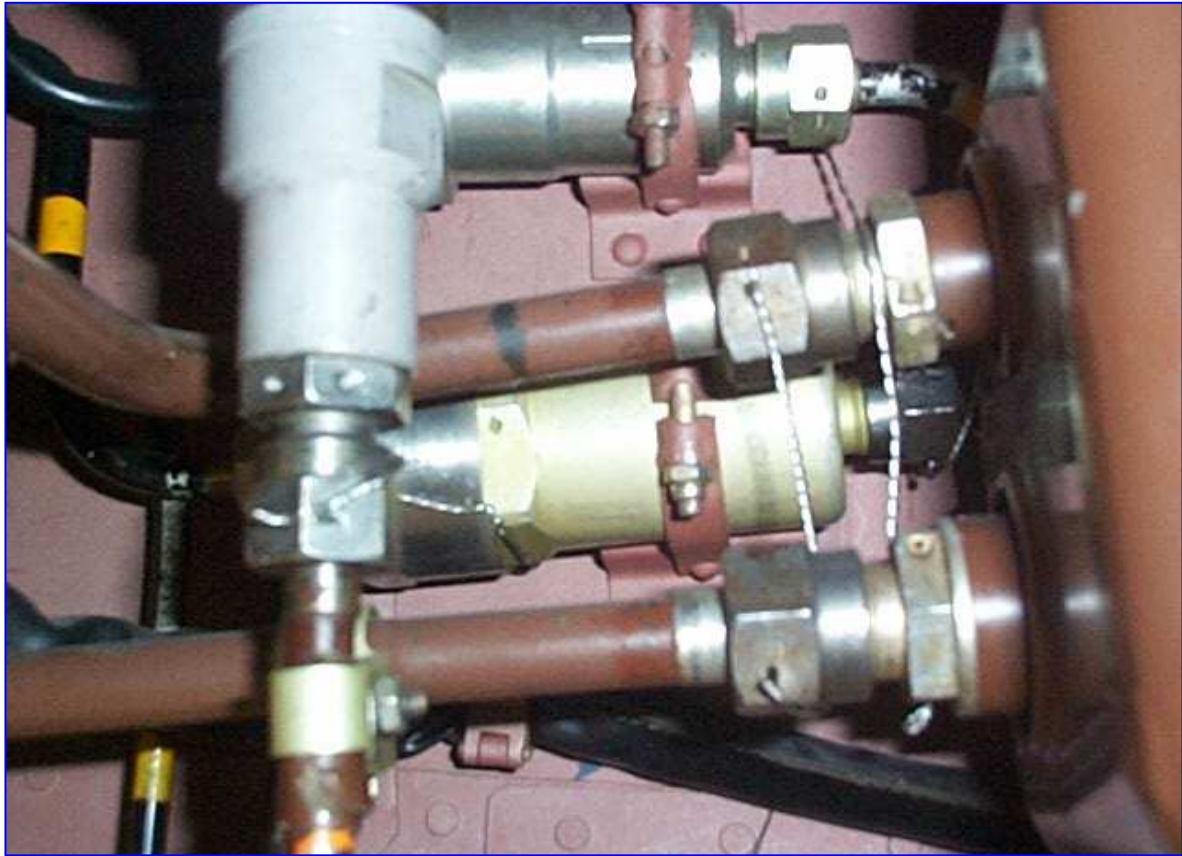
- Check valve and ceramic filter next to APU oil tank found in correct condition

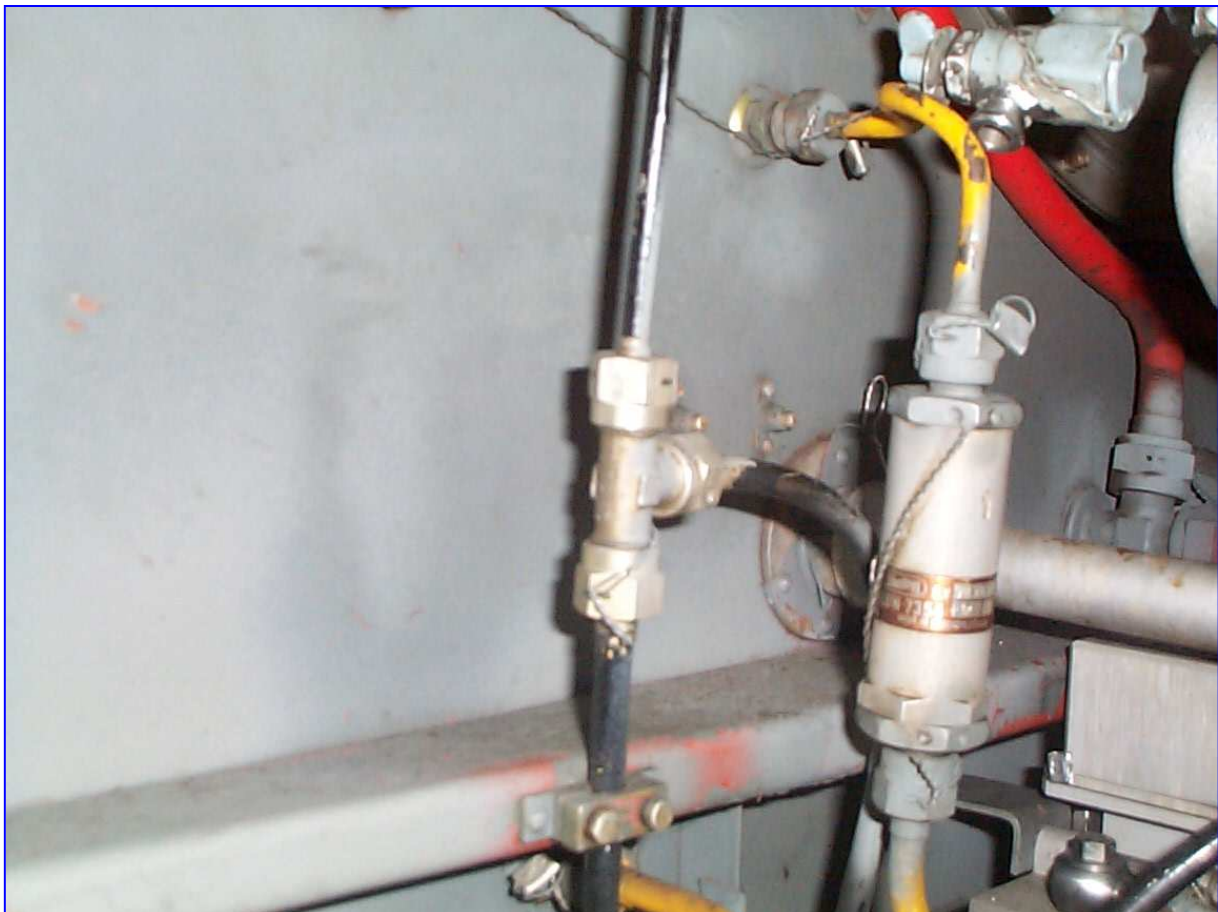
Next step was to blow shop air direct at the T-fitting on Bulkhead 32 in the line to the hydraulic reservoir. The T- fitting was original safety wired (old Russian safety wire)

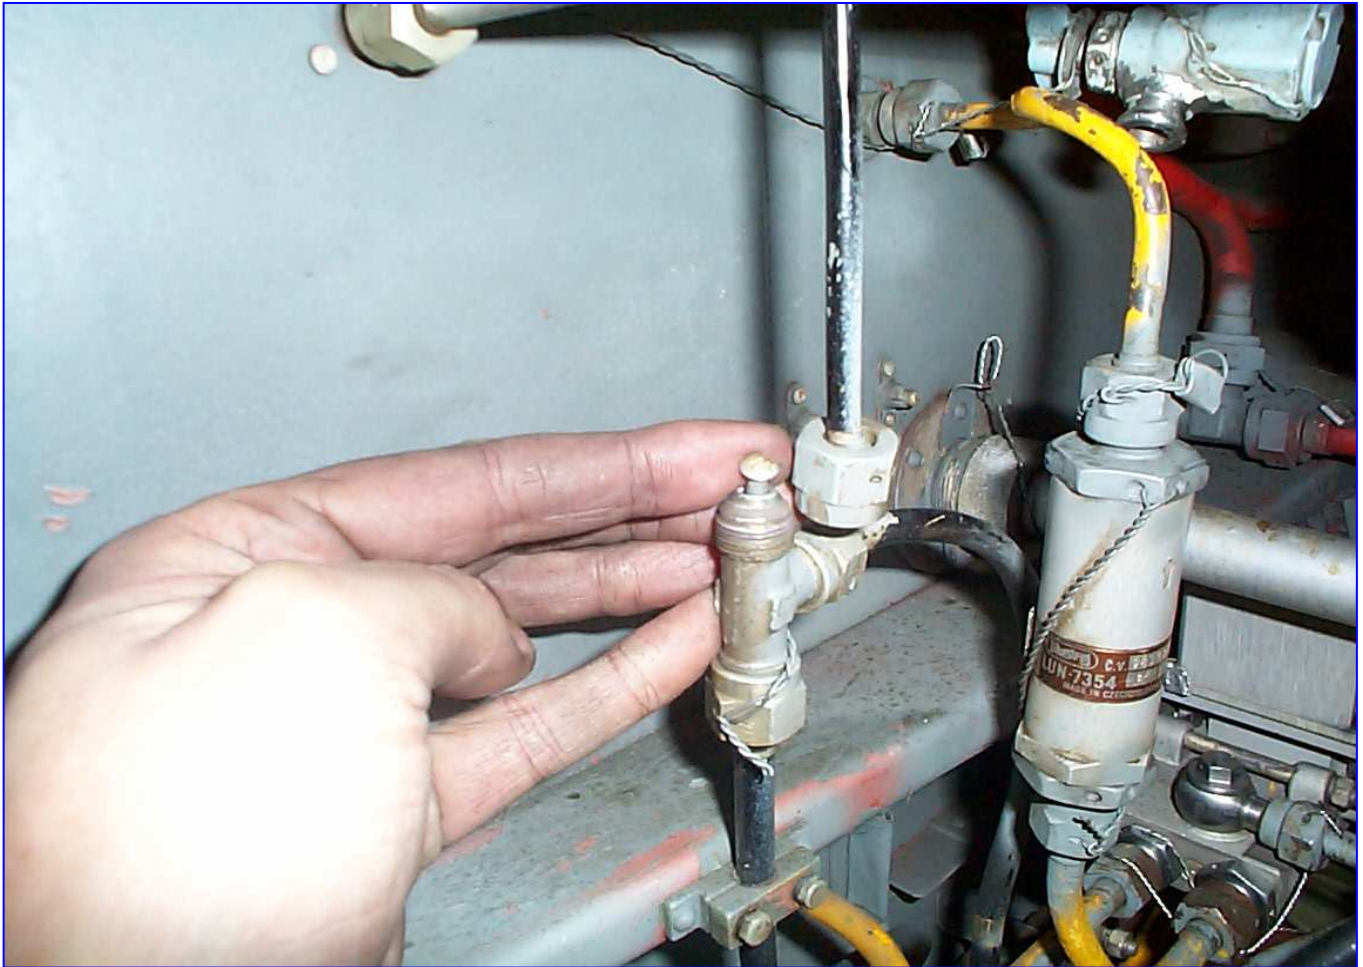
Big surprise! On the upper part of the fitting we found:

Correct...**a very careful installed round head rivet, plugging the line to the hydraulic reservoir!**

The rivet was removed and the system worked just perfect. The pump produced now 150/150 kp/cm² pressure. However it was too late for the pump!

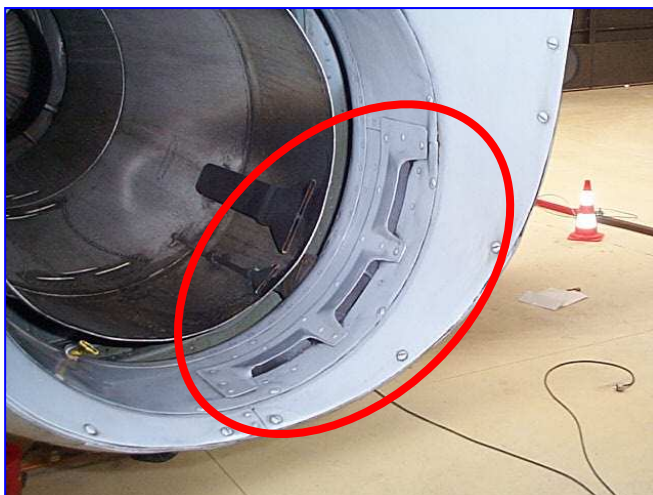
On the tail pipe we found a lot of hydraulic fluid coming out of the engine drain line. Due to the missing head pressure the pump cavitated on the suction side and was internally worn out. The permissible leak rate on Fitting No. 4 of the pump was far exceeded.

Tail pipe has been cleaned already on this picture!
