AERO - CONTACT News Letter III September, 2003

Advices for engine compressor IDB Check!

As a result of the crash investigation in Duxford/UK, on Friday Sept. 5th 2003 *aero-contact* was asked by the British AAIB to provide instructions for the L-39 operators on how to check the torque on the compressor IDB.

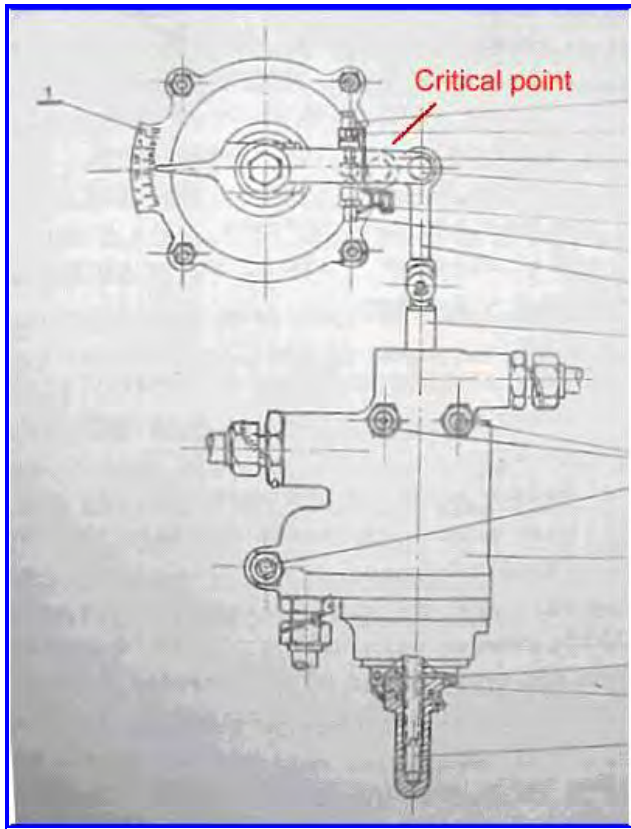
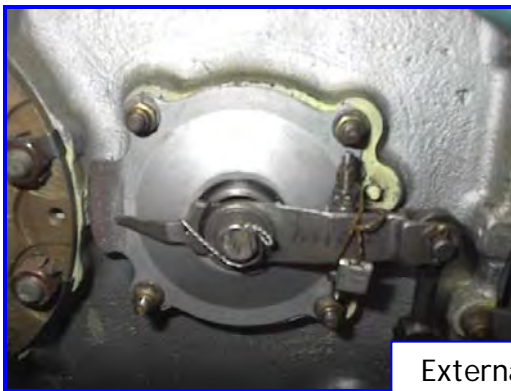
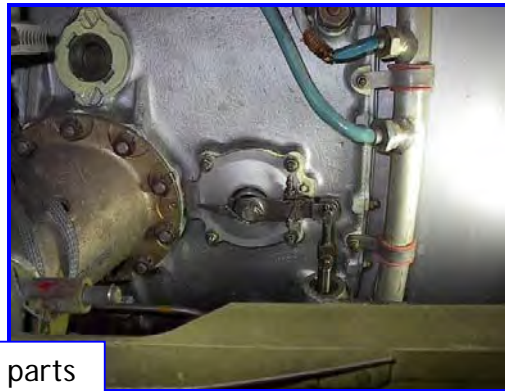
Controlled by the FCU R-4000, a "hydraulic" actuator transfers the necessary force to move the blades of the IDB over a lever (No.8) to the Level-Pointer (No. 6). The level-pointer is sitting in a slotted bushing of the drive shaft (connecting shaft No.3). On some engines the torque of the IDB increases and exceeds the limit. This leads to:

- 1.) A malfunction of the system and to a possible unstable engine compressor work.
- 2.) In the worst case it finally leads to a break of the level pointer.

One such case (2.) occurred in the East Germany Air Force.

Broken level pointer of GDR L-39ZO No. 149

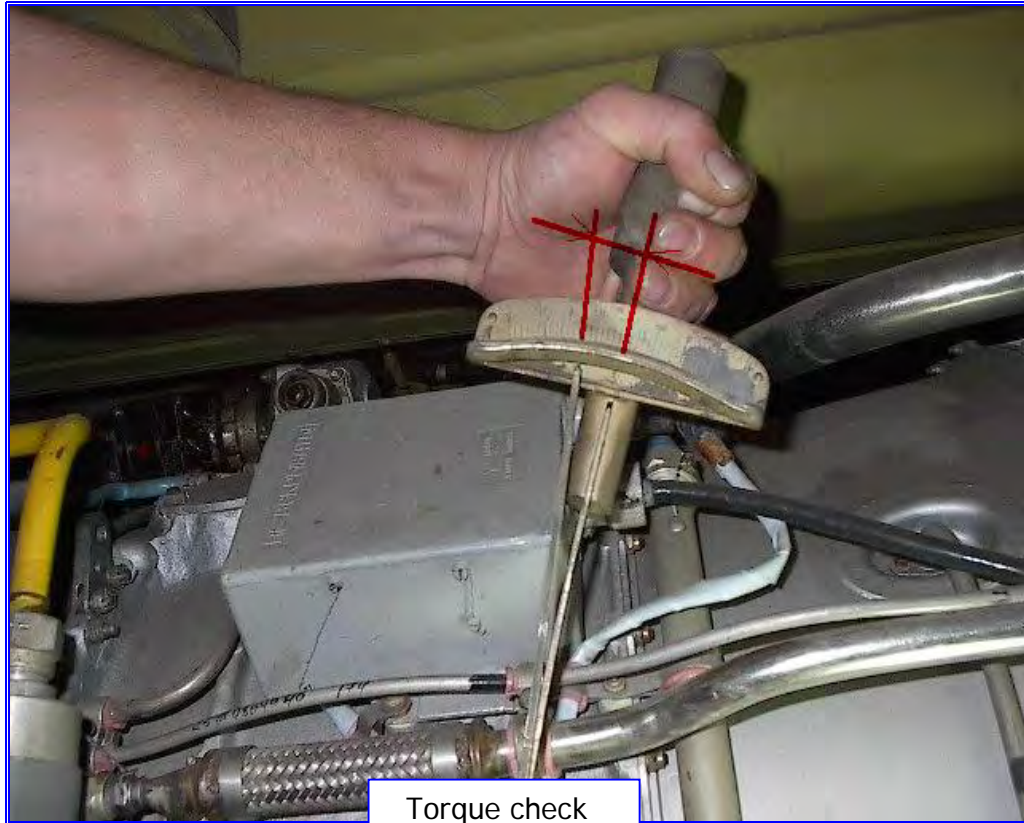
New or overhauled engine
Engines in operation

Mt \leq 0,8 kpm
Mt \leq 1,1 kpm

Since 1983, the torque check is part of the work during the installation of **new or overhauled** engines and during the **100 and 200 hrs inspection**. In order to perform the torque check, the torque limiting spanner 25.19.01.140 out of the engine tool kit 25TL.19.00.030 must be used.
