L-39 sabotaged !

During an L-39 inspection and repair in France last week we run into the following problem:

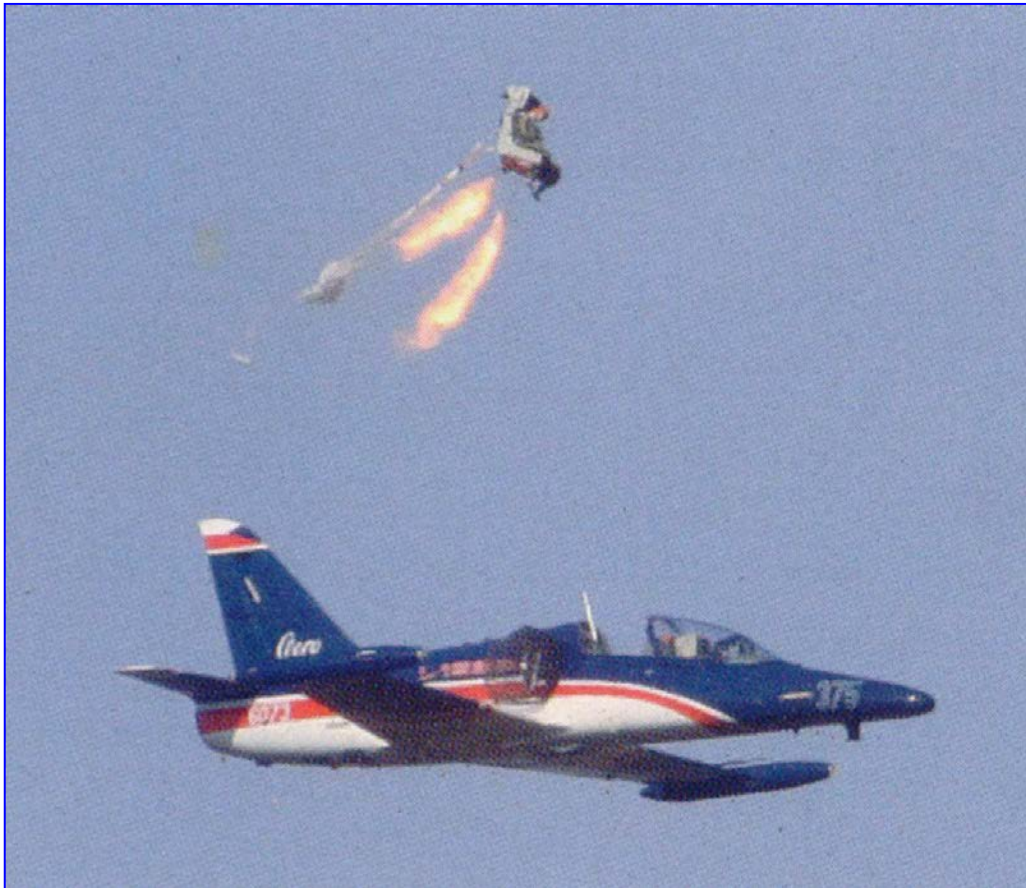
If the pump would have failed in flight and because of the inop hydraulic emergency system (dead accumulators) only two options for the airplane and its crew remained

Belly landing

OR
